**Arana Gulch Watershed Enhancement  
Plan Phase 1:  
Steelhead and Sediment Assessments,  
Santa Cruz County, California**

February 2002

Balance Project Assignment 99005.08

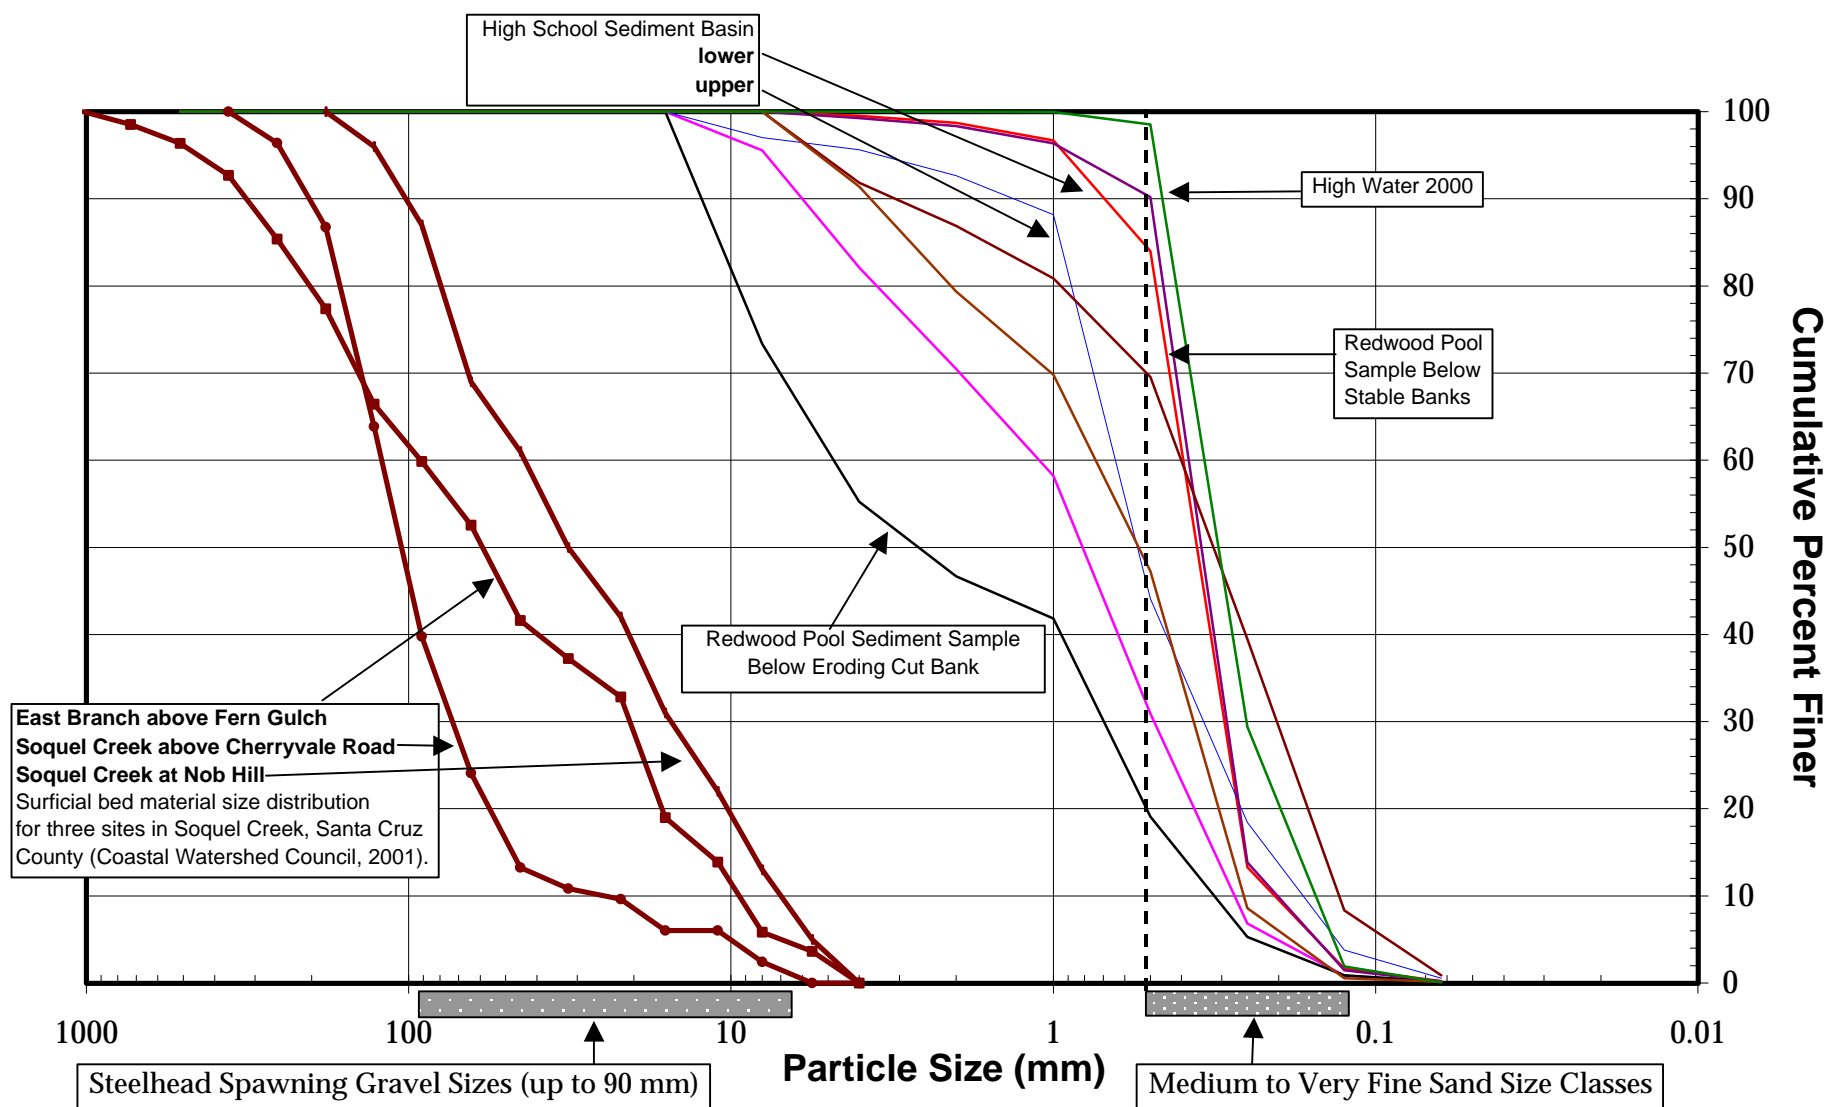
**Figure ES-2: Particle-size distribution of sediment samples from the channel and high water marks of Arana Gulch.**

Note that the 50 percentile for 6 out of 8 samples falls within or near the medium to fine sand class sizes and that sizes needed for steelhead spawning were found in only three samples, one being situated below an eroding road bank. Three samples collected from nearby Soquel Creek are shown for comparison. The size distribution curves illustrate that the coarsest material found in Arana corresponds to the finest size fractions sampled in Soquel Creek.

Sand-sized sediment fills almost all pools, holes, and other resting places in Arana Gulch from the headwaters to the mouth at the Santa Cruz Small Craft Harbor (**Figure ES-2**). Further, riffles throughout the creek are mantled with sand. In part, the sand is intrinsic to the stream, since Arana Gulch has evolved in a sandy geologic environment; however, the extent to which sand overwhelms pools and riffles in this stream system is probably much greater than usually prevailed under natural conditions. The underlying sandstones and siltstones (Purisima Formation), as well as unconsolidated terrace deposits tend to weather to sand and silt, with very little gravel- or cobble-sized debris. Silts and clays tend to wash rapidly through this relatively short, steep watershed, leaving significant volumes of sand for the stream either to (a) transport to Monterey Bay or (b) store in its channel or floodplain.<sup>2</sup> Channel reaches situated below logjams and culverts on the eastern, central and western branches of Arana Gulch do contain gravel and cobbles, often buried beneath a foot or more of sandy sediments. For these coarser materials to provide spawning or rearing habitat, the volume of sand in the stream will need to be curtailed. The volumes of sand in the channel have been growing since the watershed has been settled, grazed, farmed, and cleared, and as the networks of roads, paths, and gullies expand. As long as the sandstone canyons are occupied, well-planned stewardship of the streams can help offset the effects of these uses.

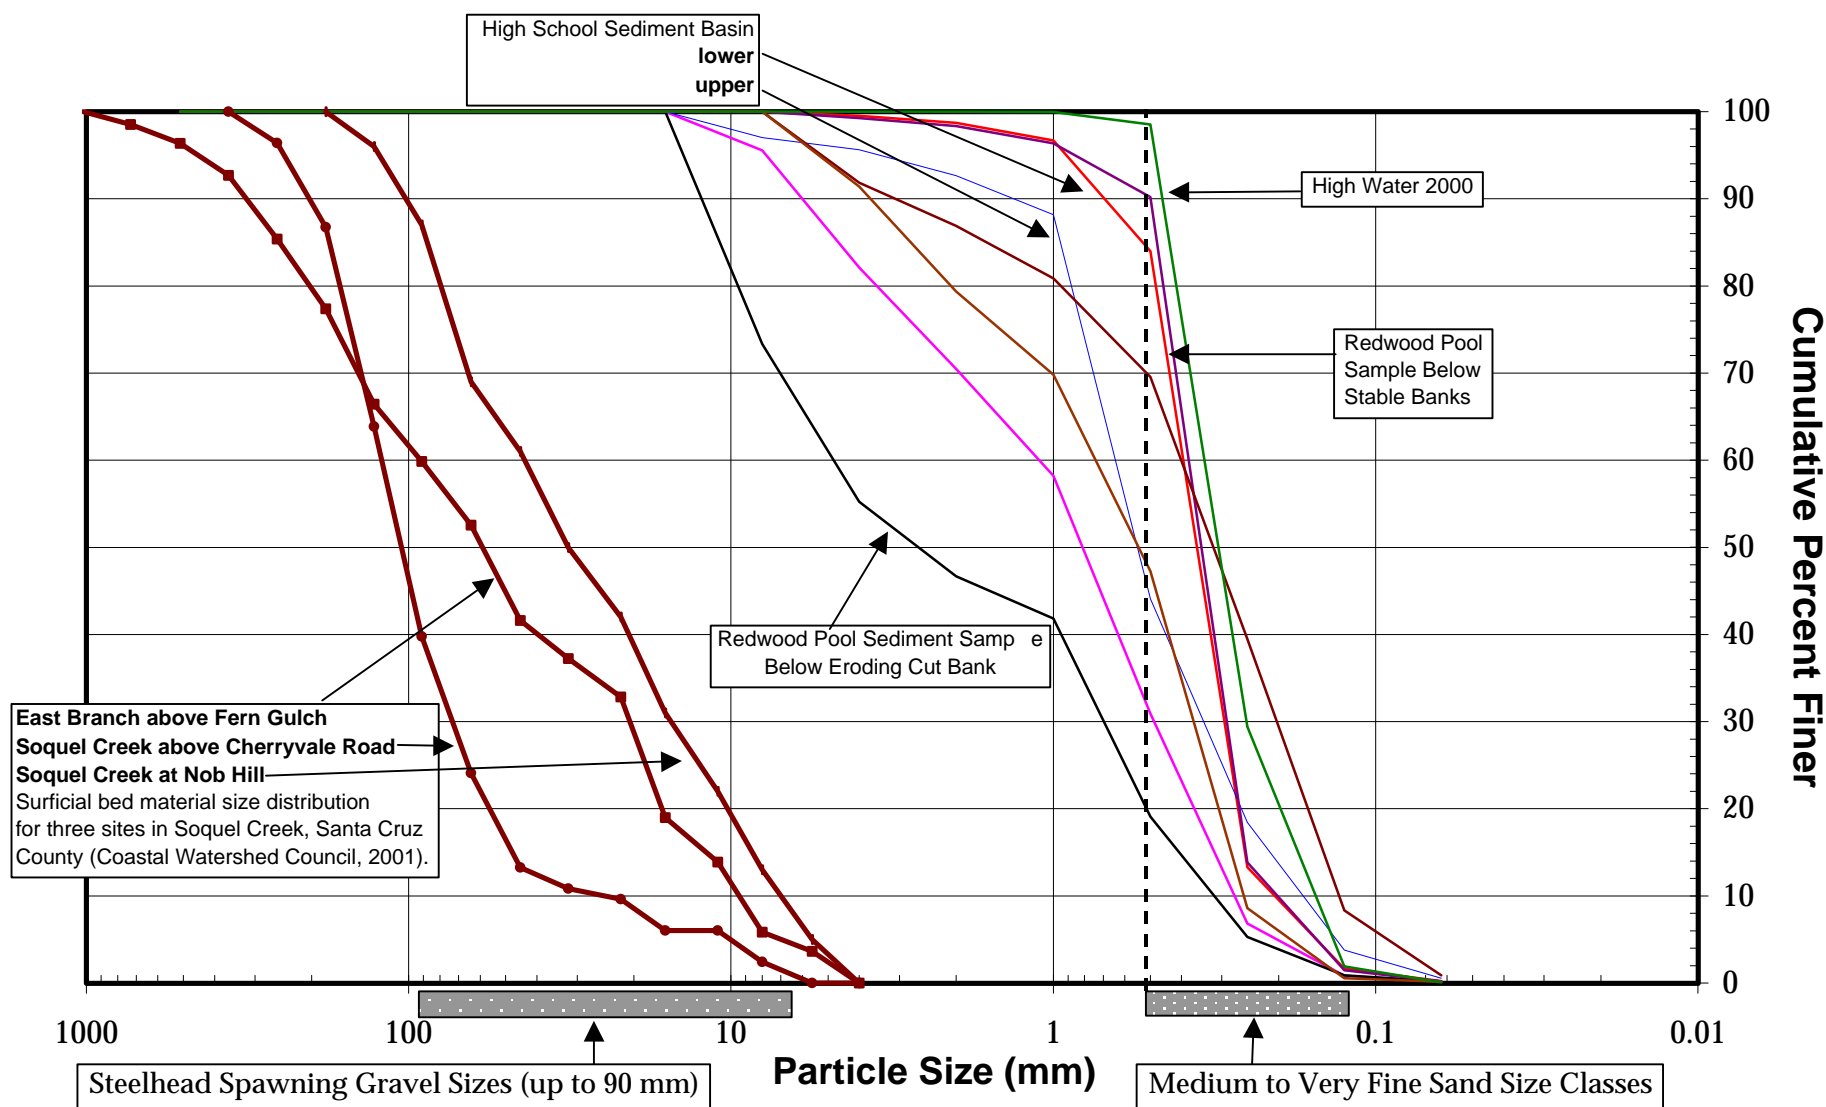
**Figure 5.1: Particle-size distribution of sediment samples from the channel and high water marks of Arana Gulch.**

Note that the 50 percentile for 6 out of 8 samples falls within or near the medium to fine sand class sizes and that sizes needed for steelhead spawning were found in only three samples, one being situated below an eroding road bank. Three samples collected from nearby Soquel Creek are shown for comparison. The size distribution curves illustrate that the coarsest material found in Arana corresponds to the finest size fractions sampled in Soquel Creek.
